**A CASE STUDY: DAMAGE TO THE METROPOLITAN
OAKLAND INTERNATIONAL AIRPORT CAUSED BY
THE LOMA PRIETA EARTHQUAKE**

Barney A. Vallergera

William P. Grogan

Final Report

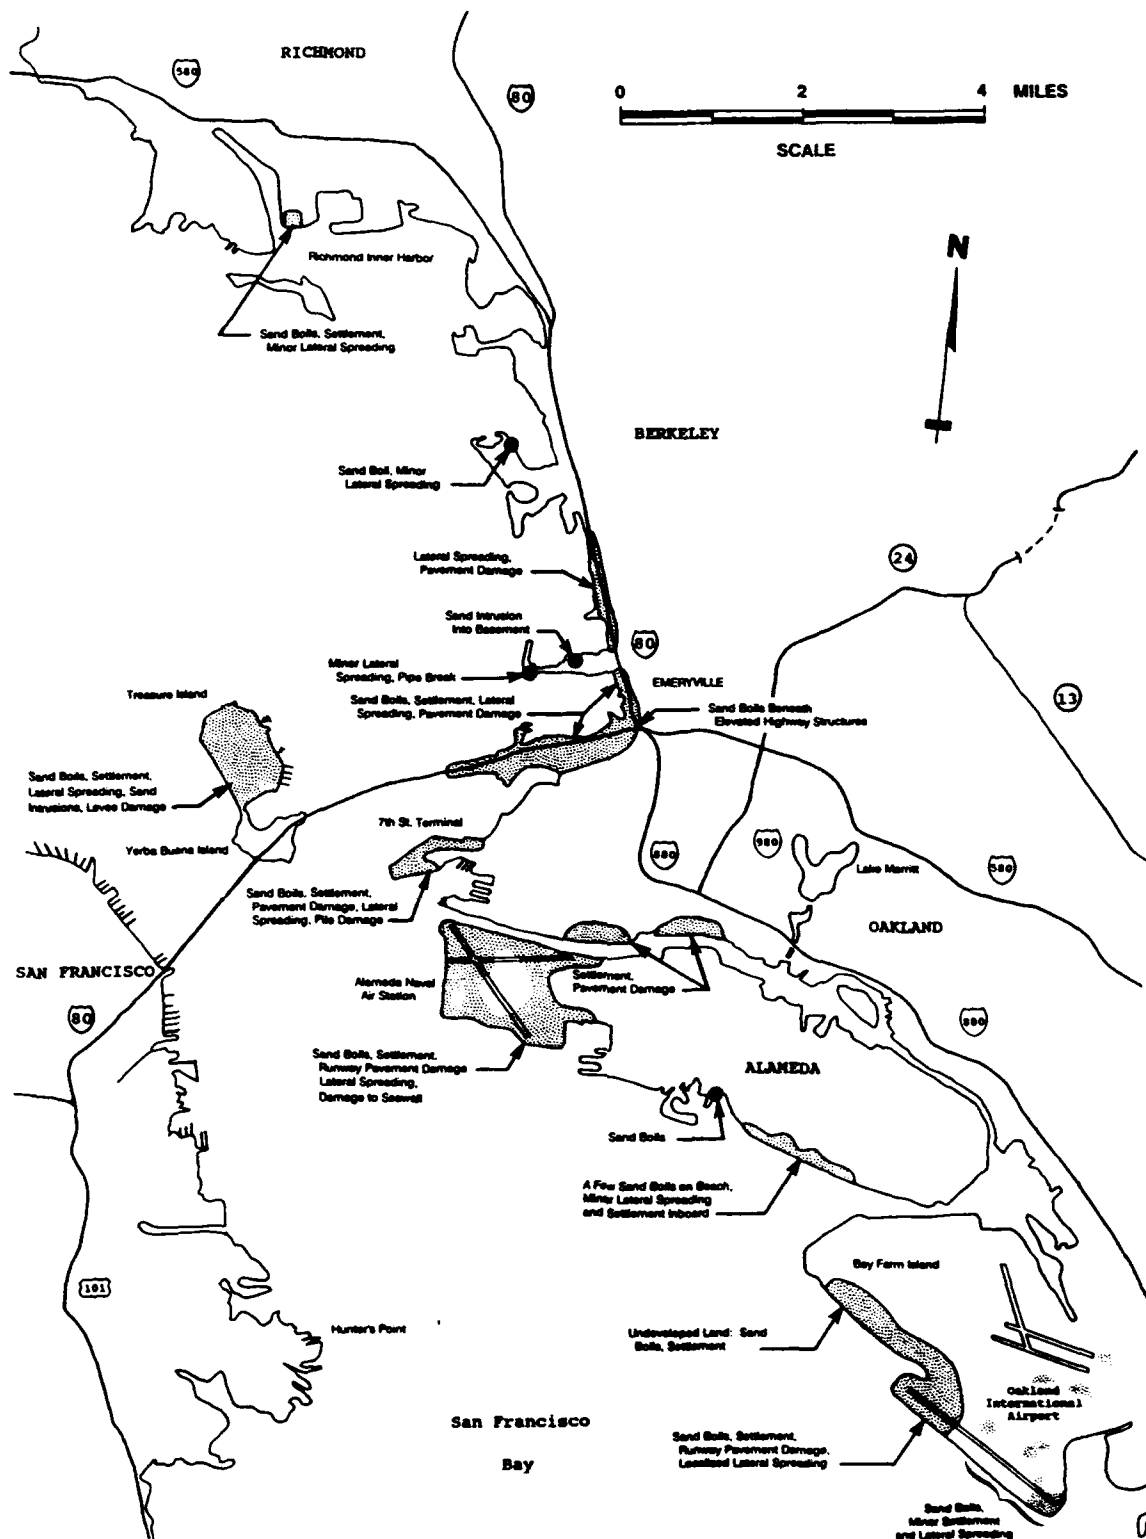
Figure 1. East bay areas suffering damage because of liquefaction

Map of the East San Francisco Bay Shore Region Showing Sites Which Experienced Liquefaction During the Loma Prieta Earthquake of October 17, 1989
